Zirconia: Clinical Impressions

An In Vivo Comparison of the Aesthetics of Various Zirconia Crowns

Brent
Engelberg, DDS

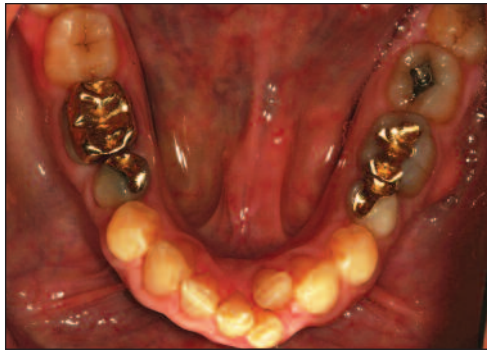
Figure 1. Preoperative view of lower arch, including failing restorations on teeth Nos. 29 and 30.

A 69-year-old male presented with failing gold onlay restorations on teeth Nos. 29 and 30. After several decades of service, the patient was having occasional symptoms when drinking cold beverages, and a contact had opened between the 2 teeth (Figure 1). In addition, the margins were slightly open in several areas around both gold restorations, and

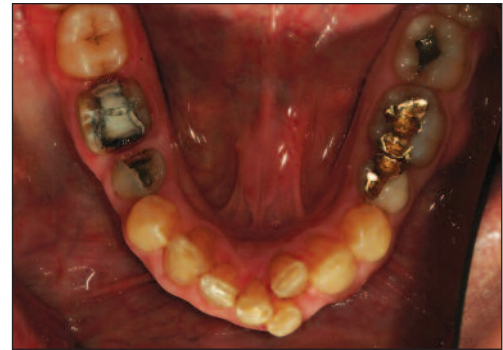
Figure 2. Working view of the lower arch teeth after restoration removal.

carpule of Septocaine (Septodont), and the teeth were isolated (Isolite [Isolite Systems]). The old restorations were removed using a raptor 557 bur (Axis Dental) and a high-speed electric handpiece (KaVo Dental Handpieces) (Figures 2 and 3). The remaining cements, liners, and caries were removed with a series of diamond burs, ie, KSo, KS1SC, KS3SC, and KS5SC (KOMET USA) and the rough crown margins were initially prepared (Figures 4 and 5).

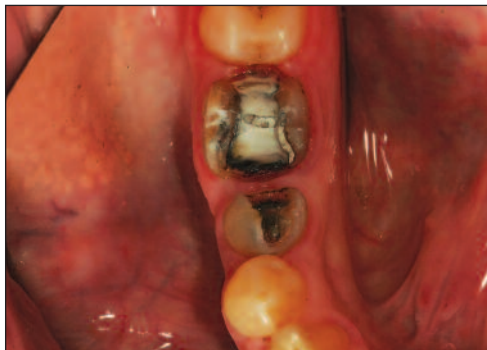
Figure 3. Close-up view of teeth Nos. 29 and 30, demonstrating decay and leaking restorations.

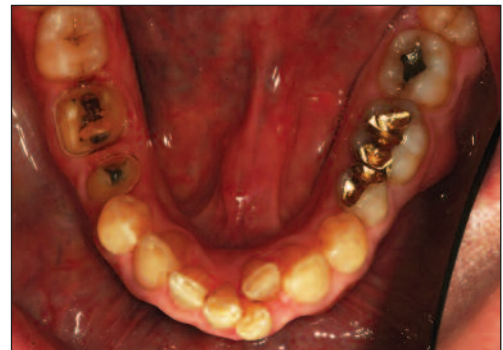
Figure 4. Lower arch view after initial cleanup.

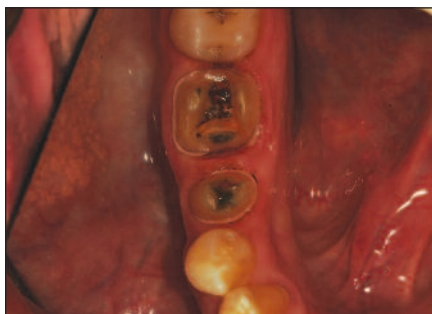
Figure 5. Close-up view of teeth Nos. 29 and 30, after caries removal and initial margin placement.

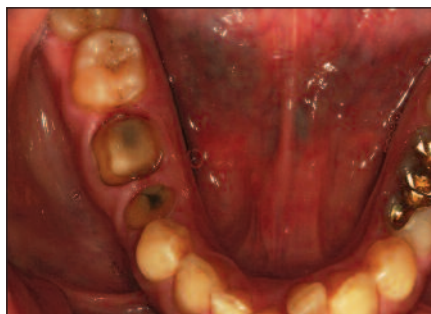
Figure 6. Lower arch view of the completed preparations.

After all visible caries were removed (Figure 6), the remaining dark areas were verified to be sound, and an anti-microbial scrub (Consepsis Pumice Scrub [Ultradent Products]) was applied to the preparations and brushed across the teeth with a Star Brush (Ultradent Products) inside a slow-speed latch handpiece (KaVo Dental Handpieces). A size 1 retraction cord (GingiBRAID [DUX Dental]) was carefully placed in the sulcus of both teeth to avoid fluid contamination during the crown buildups and to minimize bleeding poten-

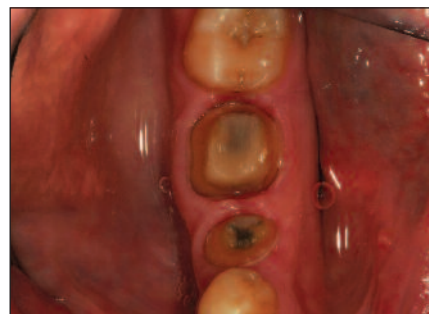
Figure 7. Close-up view of teeth Nos. 29 and 30, after crown buildups and preparation completion.

Next, the preparations were completed, and the final margin positions were established and smoothed with the KS3SC, KS5SC, KS6SC, and 8856.021 burs (KOMET USA). Careful consideration was made to ensure accurate and smooth margins with minimal disruption to the surrounding tissue; even on the mesial of tooth No. 30 where the previous restora-

tion’s margin was slightly subgingival (Figures 7 and 8).

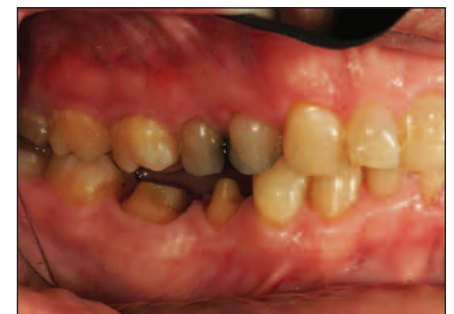
Figure 8. Lateral view of the completed preparations.

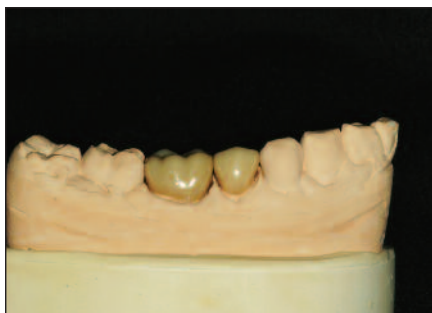
Figure 9. Laboratory lateral view of the full-contour zirconia polished restorations.

1. Full-contour zirconia: polished only (FCZP) (Figure 9)
2. Full-contour zirconia: stained and glazed (FCZSG) (Figure 10)
3. Layered porcelain (2 layers) dur-

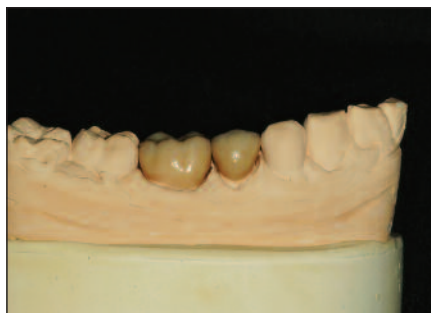
Figure 10. Laboratory lateral view of the full-contour zirconia stained and glazed restorations.

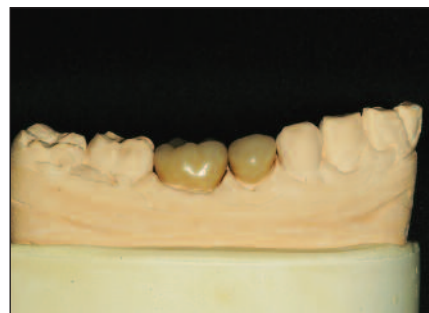
Figure 11. Laboratory lateral view of the layered zirconia restorations.

ing a zirconia coping (LPZ) (Figure 11)

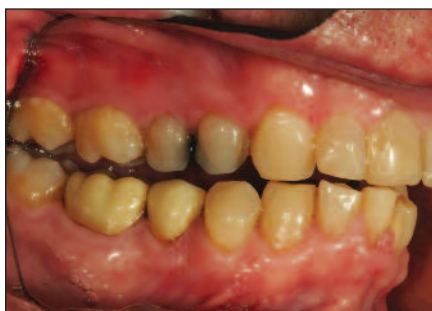
Figure 13. Clinical lateral view of the full-contour zirconia polished restorations.

In the case of the full-contour restorations, the FCZP pair appeared to have a high luster, and the physical zirconia material simply looked different in every way than a natural tooth (Figures 13 and 14). Zirconia is opaque by nature,^{7,8} and the more translucent a restoration is (given a healthy preparation stump shade), the more natural

the restoration will appear.^{9,10} As there is no ability to “block out” the opaque zirconia coping with layering, the polished-only crowns’ opacity stood out significantly among the surrounding natural dentition.

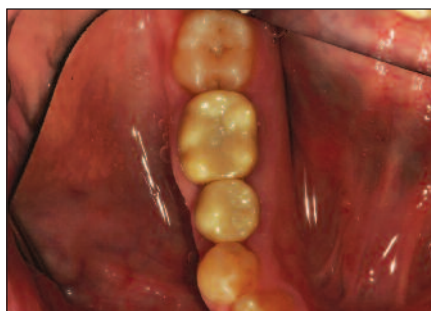
Figure 14. Clinical occlusal view of the full-contour zirconia polished restorations.

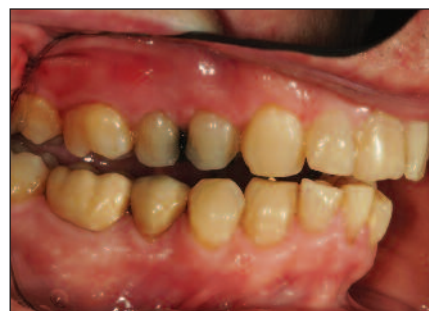
Figure 15. Clinical lateral view of the full-contour zirconia stained and glazed restorations.

The FCZSG pair clearly appeared more aesthetic than the FCZP crowns (Figures 15 and 16). From the author’s experience, in restorative situations where there is a dark preparation stump, zirconia restorations are often considered or selected as the coping material. This selection is based on zirconia’s ability to block the dark underlying stump from show-through in the restoration.^{7,11} However, if the entire crown is comprised of this opacous material, the limited light transmission through this thickness of restorative material appears to have a substantial aesthetic downside. In fact, while the FCZSG crowns offered slight aesthetic improvement, it is very difficult to consistently stain and glaze an all-zirconia crown.¹²

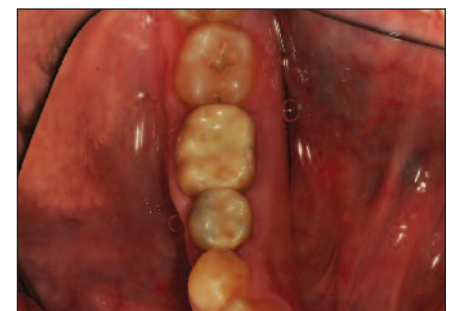
Figure 16. Clinical occlusal view of the full-contour zirconia stained and glazed restorations.

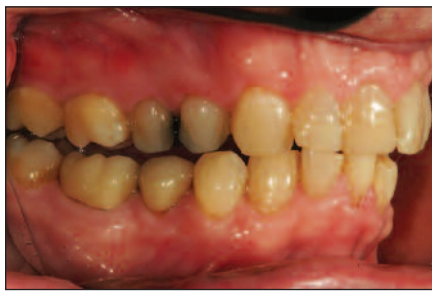
Figure 17. Clinical lateral view of the layered zirconia restorations.

It was subjectively determined that the 2 varieties of layered crown pairs were aesthetically superior. Not only did the layered restorations more closely mimic the natural shade and translucency characteristics of the surrounding natural dentition; they looked far more realistic to the patient himself. When layering the porcelain, a zirconia coping is designed to fit to the restoration margin, much like a metal coping would be designed prior to layering porcelain over a PFM crown.^{13,14} Although the zirconia coping is opaque, the porcelain layered over it can be much more translucent. The combination of coping and layered porcelain can produce very aesthetic results while still achieving an extremely accurate marginal fit of the crown without adding substantial fabrication time.^{15,16}

There was a slight increase in aesthetics with the MLPZ pair versus the LPZ pair (Figures 17 to 20), and this was selected as the crown pair to

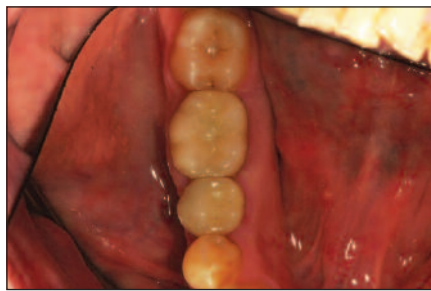
Figure 18. Clinical occlusal view of the layered zirconia restorations.

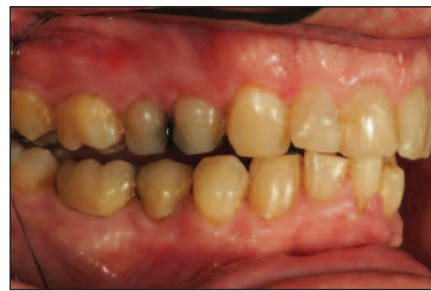
Figure 19. Clinical lateral view of the multiple layered zirconia restorations.

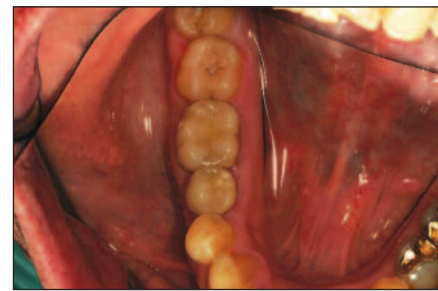
Figure 20. Clinical occlusal view of the multiple layered zirconia restorations.
